**Agilent – Santa Clara
CO-3**

**SGI/Google
CO-4**

Stanford University Medical Center
CO-5

Gap Corporate Headquarters
CO-6

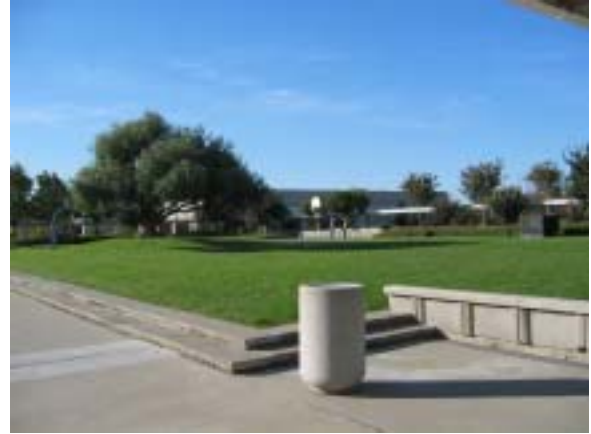
Large areas of vegetation are located on top of the second floor of the office building.

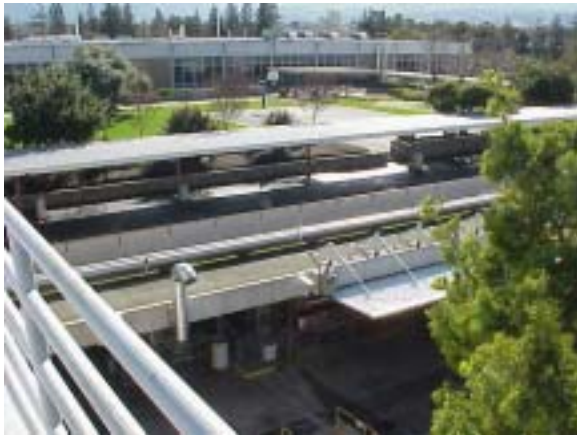
The roof garden is located on the second floor of the Agilent building.

- Leakage occurred due to roots penetrating the roof membranes, however after patching the barriers underneath the garden, leakage was prevented.
- The membrane integrity was also compromised by heavy vehicle traffic (for deliveries to the café on the roof garden level). The amount of deliveries was minimized to prevent more leaks.

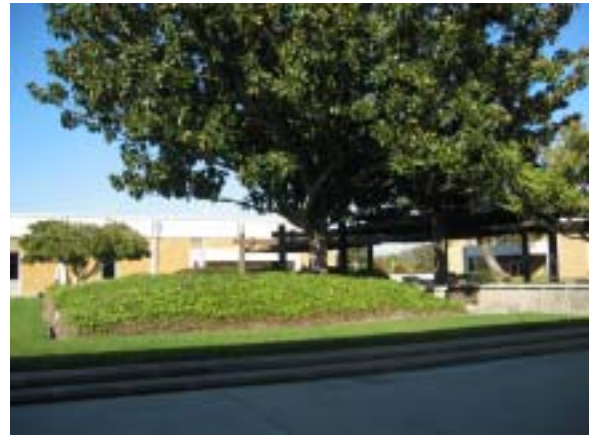
Trees are planted as part of the roof gardens.

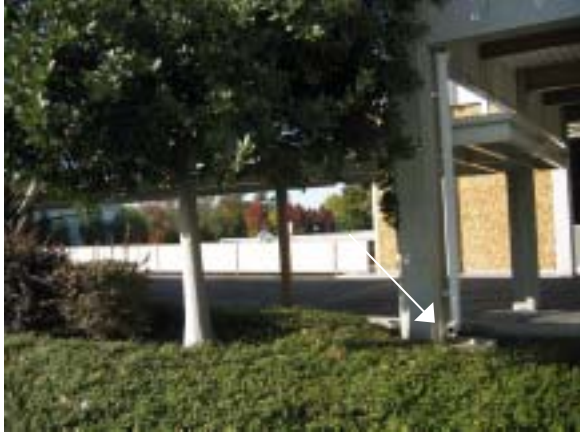
Rooftop runoff is directed to drain through the vegetation.

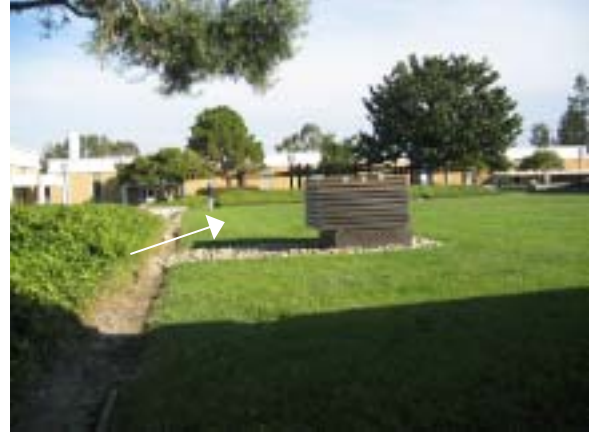
Exhaust vents for HVAC* systems are integrated into roof garden areas.

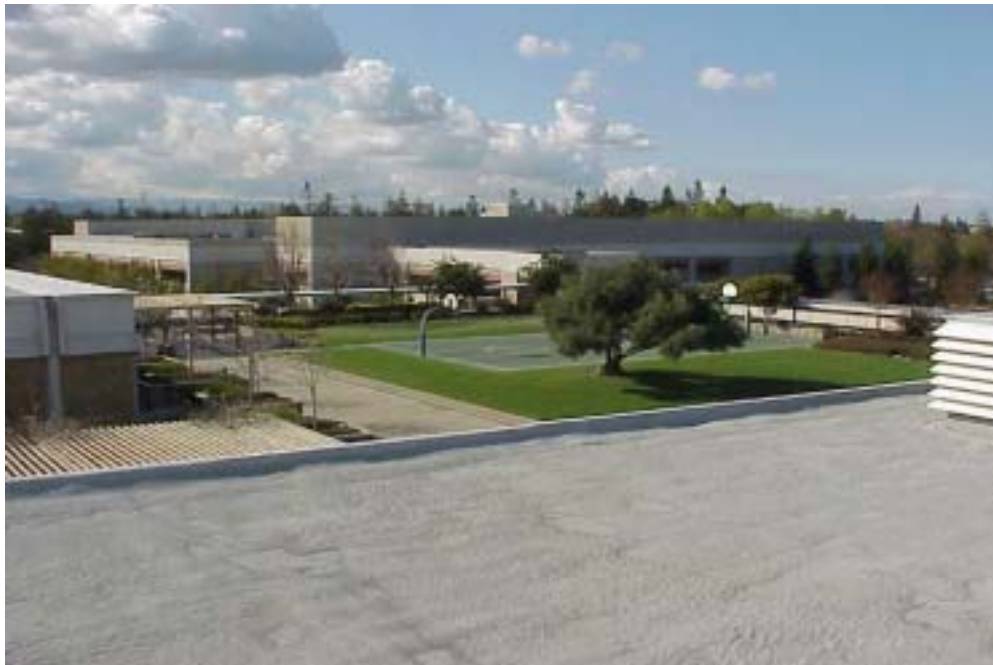
Another view of the roof garden shows a large shady tree that can reduce rainfall velocity and runoff.

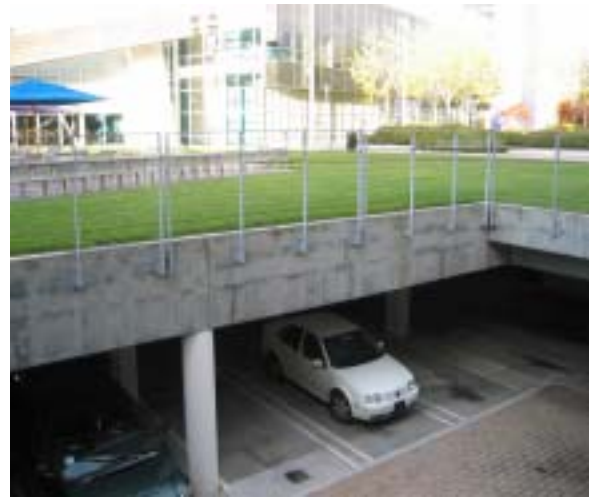
The parking lot can be seen below the turf on the level above.

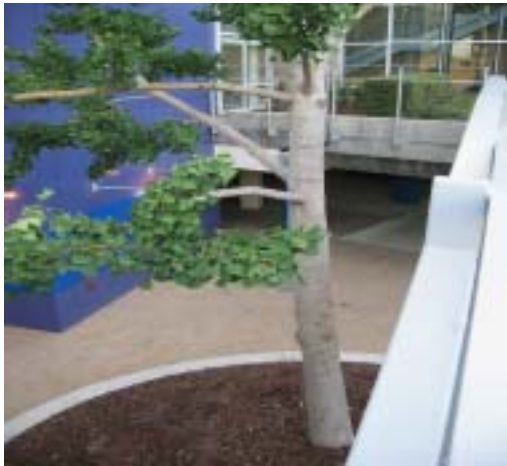
This tree in the parking lot grows up through an opening in the roof garden area. Trees and other vegetation help reduce the volume and velocity of rainwater.

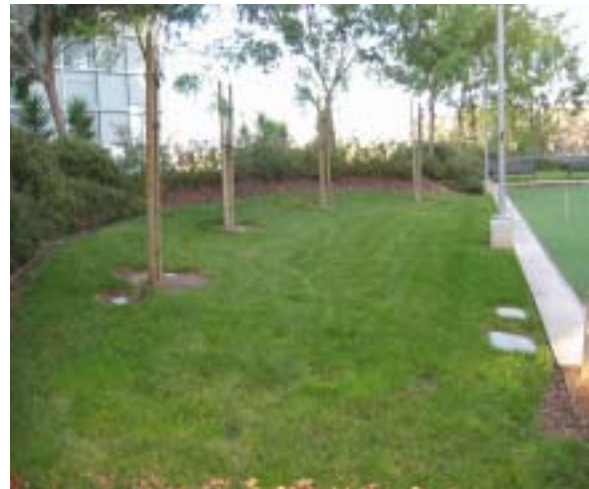
This grassy rooftop area planted with trees reduces and provides some natural treatment of runoff.

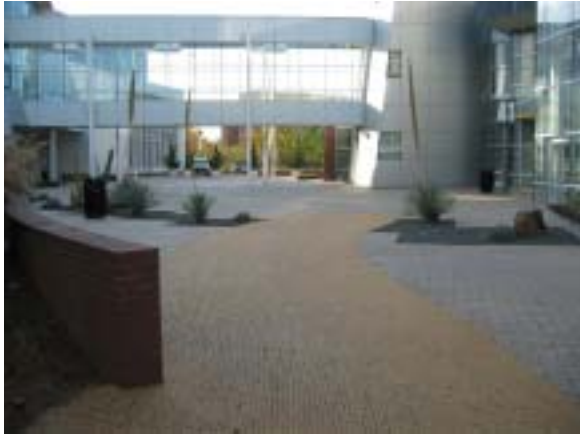
Permeable pavement is used in this courtyard.

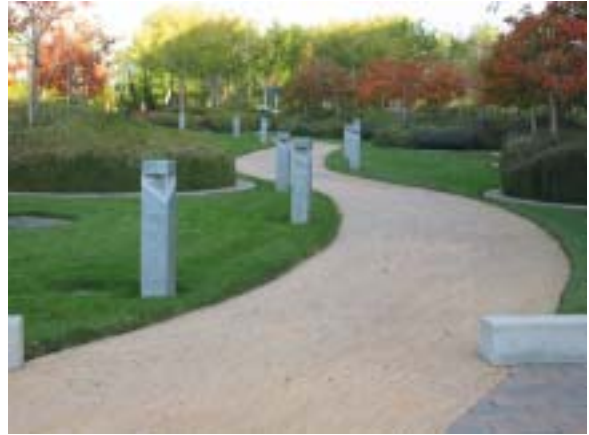
Permeable pavement and landscaped areas fill the courtyard on top of the parking structure.

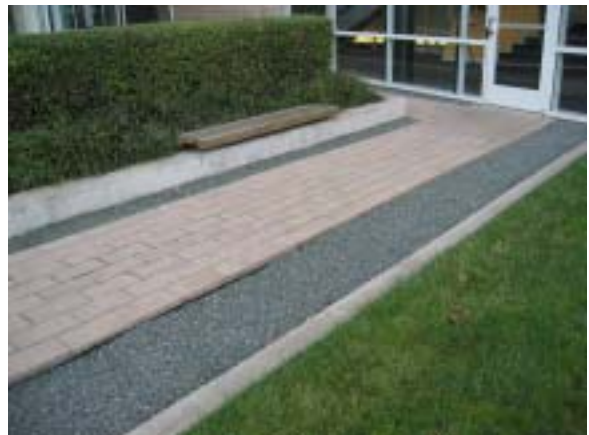
Turf and gravel surrounds this pathway, providing an area for infiltration to occur.

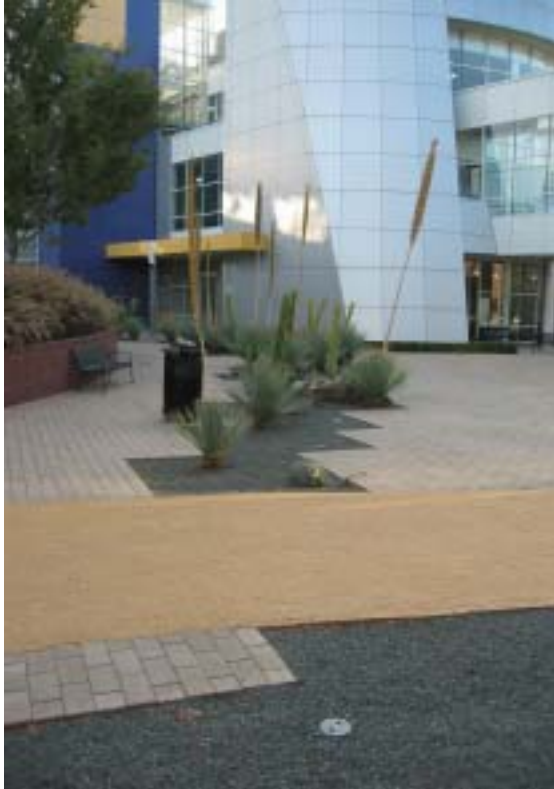
Permeable pavement and native vegetation surround this multi-story complex.

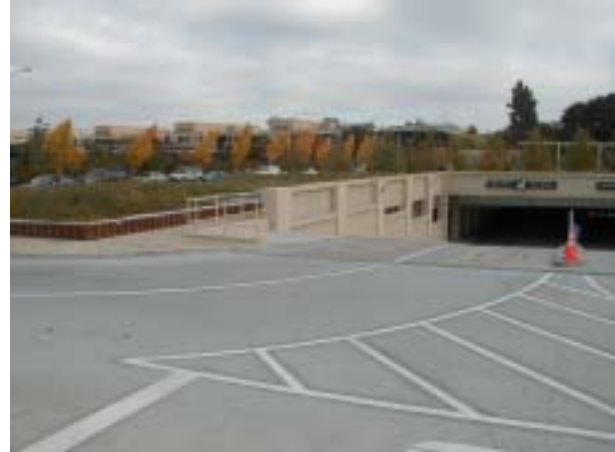
From this angle, it is possible to see the parking structure beneath the roof garden.

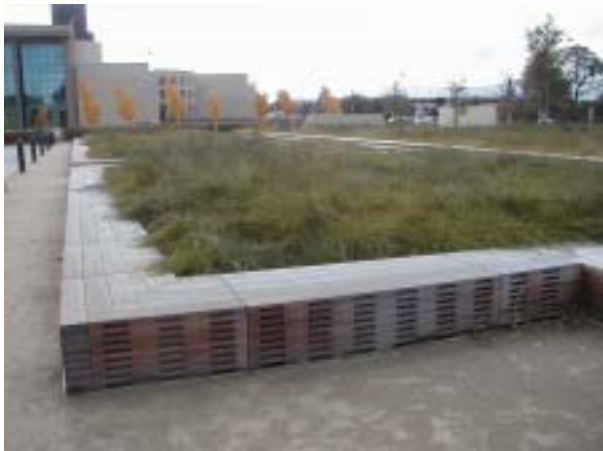
This roof garden provides not only aesthetic benefits, but also a large area for stormwater infiltration to occur.

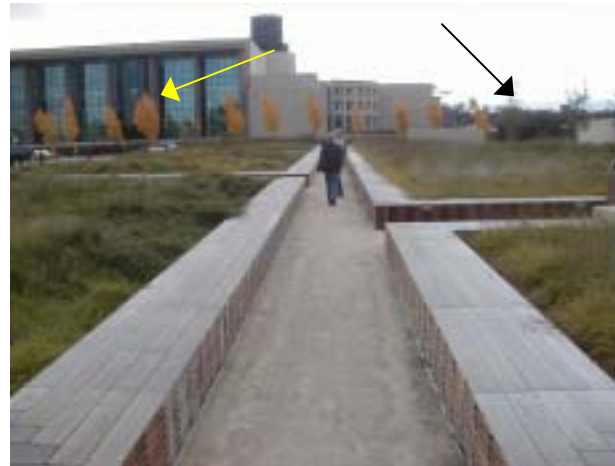
At the end of the pathway, trees line the nearby street. The trees and the rooftop vegetation reduce the volume and velocity of stormwater runoff while providing for some natural treatment.

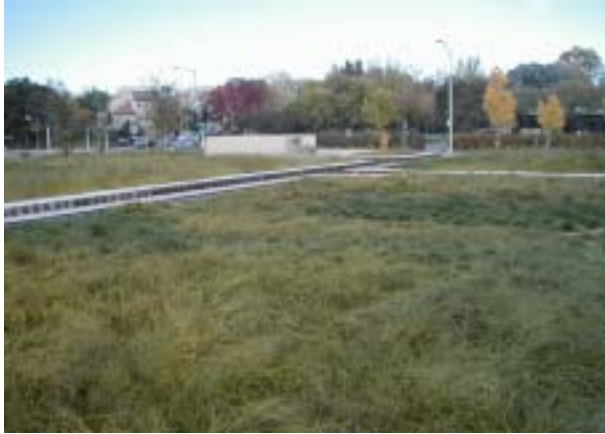
The roof garden uses only one type of vegetation, which facilitates maintenance.

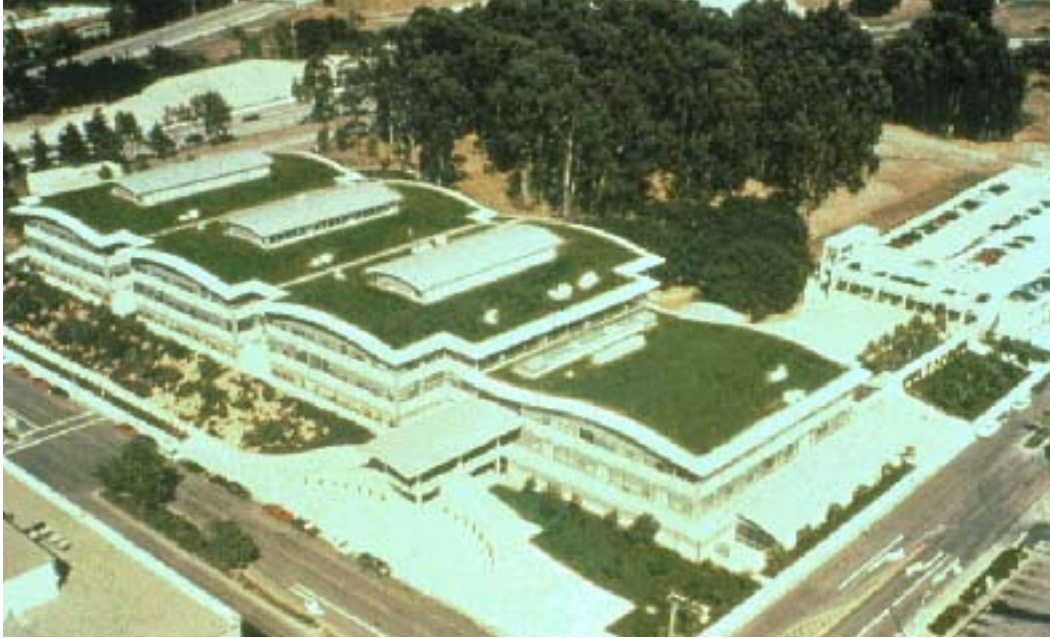
Aerial view of the building's roof garden shows the vegetative areas planted on top of the building made to appear like rolling hills.

- It is estimated that the roof garden captures and stores about 70% of the rainfall. Other benefits include better insulation of the building, reducing the costs of heating and cooling, and mitigating the “heat island effect.”

- The roof was planted using live plugs of six (6) different types of grasses (as opposed to hydroseeding or hand broadcasting) in six (6) inches of soil. The vegetation has grown to form a 5-inch mat of fibrous roots.
