**Agilent – Palo Alto
CO-1**

**Yahoo! Inc.
CO-7**

**Juniper Networks
CO-8**

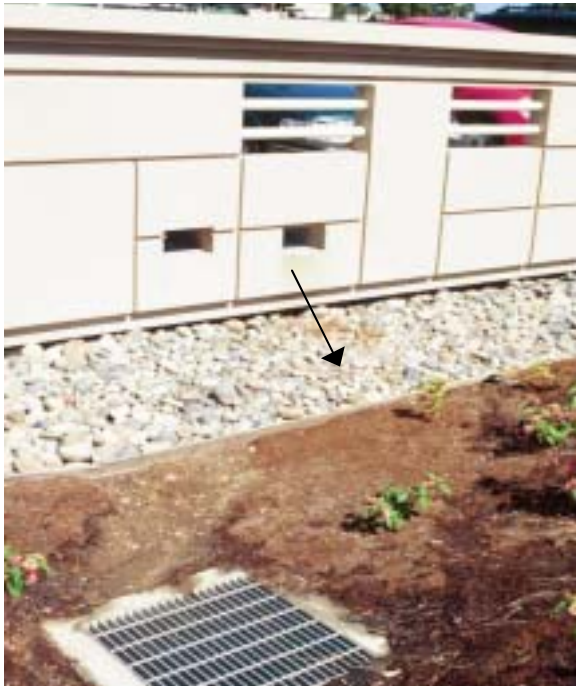
The runoff drains from the top of the parking structure to this rock filter bed for treatment and then to the storm drain system via the detention basin.

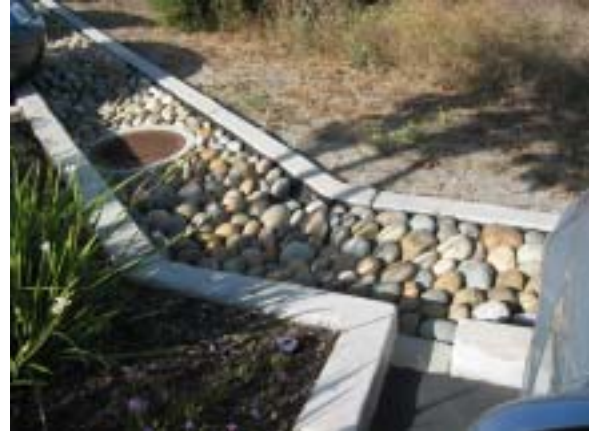
This rocky swale has a storm drain for excess flows.

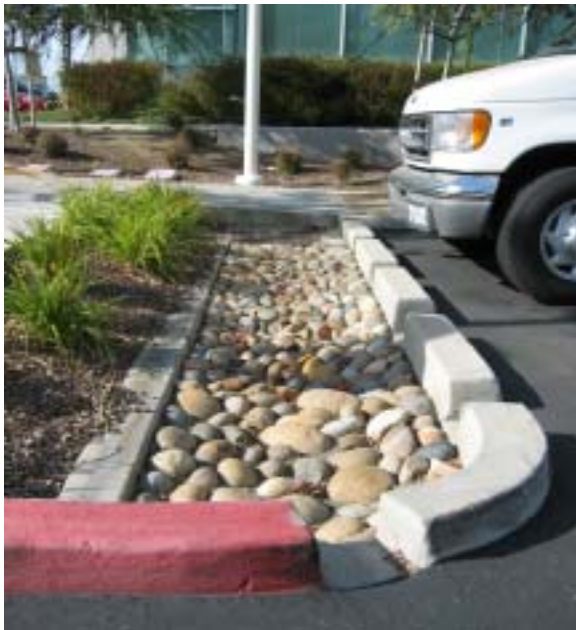
Rocky swale with curb cuts allows for infiltration to occur.

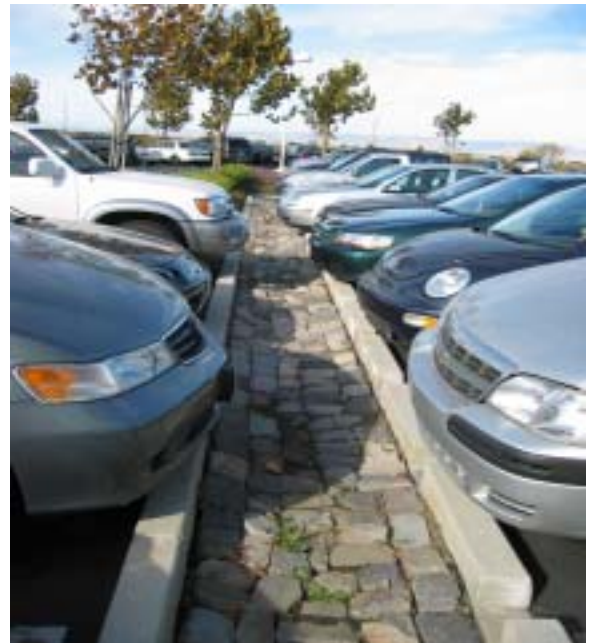
Rectangular stones are used to create a rocky swale.

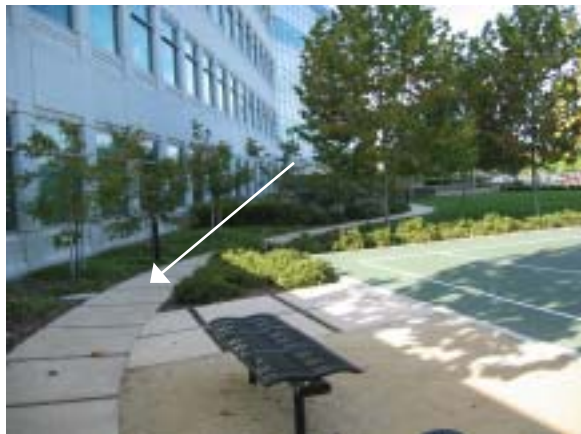
This pathway made of pervious pavers allows infiltration through the sand filled crevices. Also, these benches are provided on pervious surfaces.
