**SGI/Google  
CO-4**

1600 Amphitheater Parkway  
Mountain View, CA

## Gap Corporate Headquarters CO-6

## Porter Drive CO-9

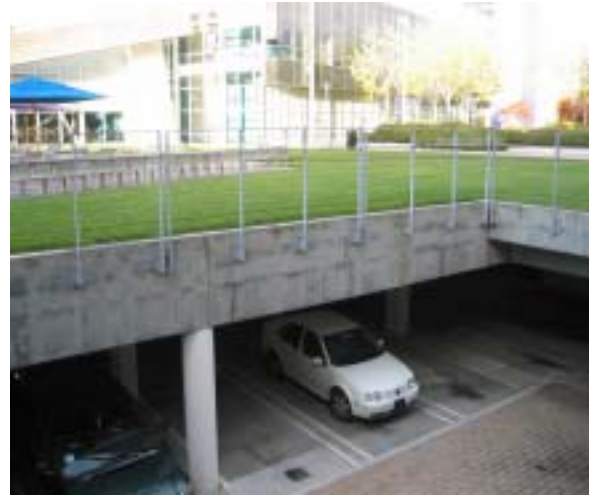
The parking lot can be seen below the turf on the level above.

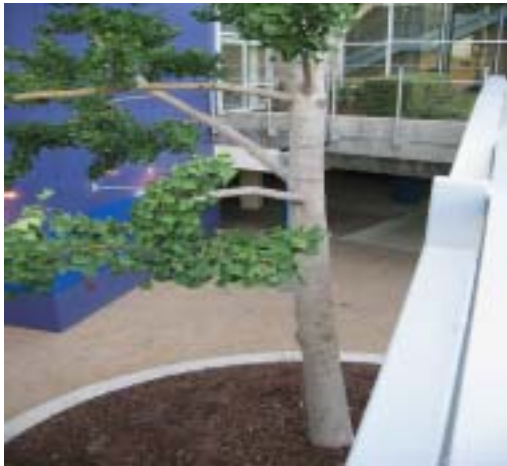
This tree in the parking lot grows up through an opening in the roof garden area. Trees and other vegetation help reduce the volume and velocity of rainwater.

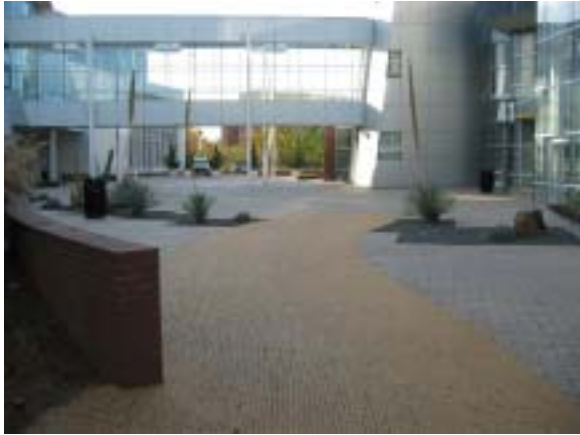
Permeable pavement is used in this courtyard.

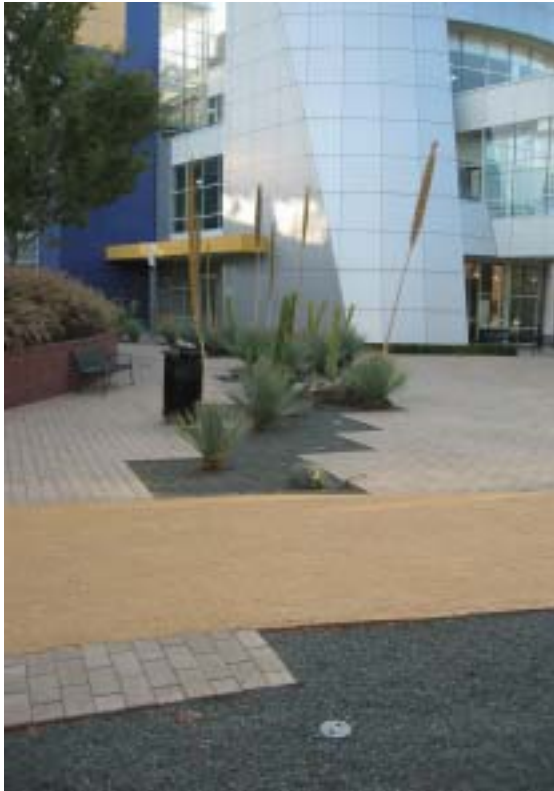
Permeable pavement and native vegetation surround this multi-story complex.

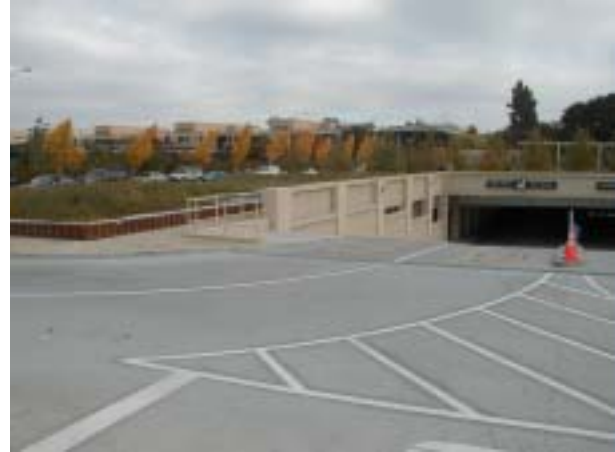
From this angle, it is possible to see the parking structure beneath the roof garden.

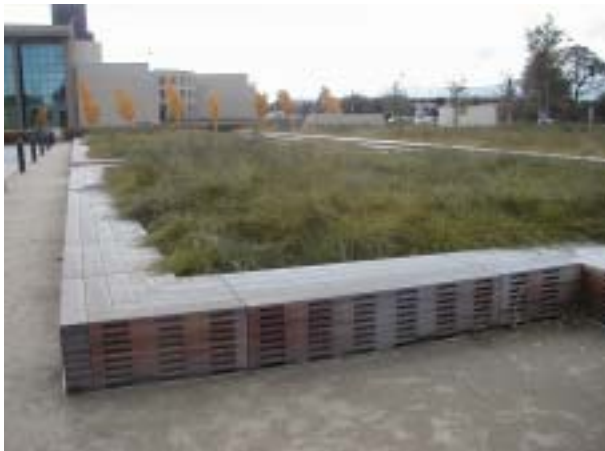
This roof garden provides not only aesthetic benefits, but also a large area for stormwater infiltration to occur.

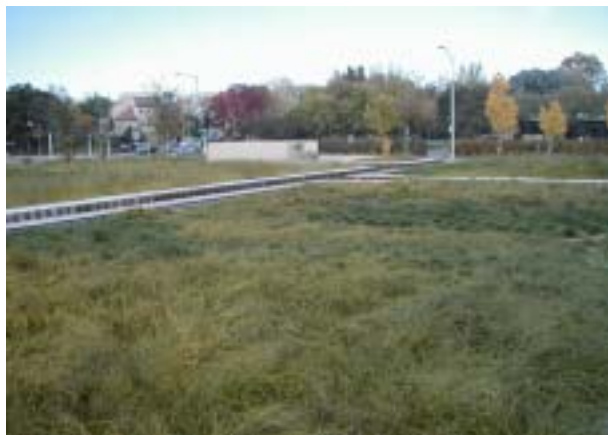
The roof garden uses only one type of vegetation, which facilitates maintenance.

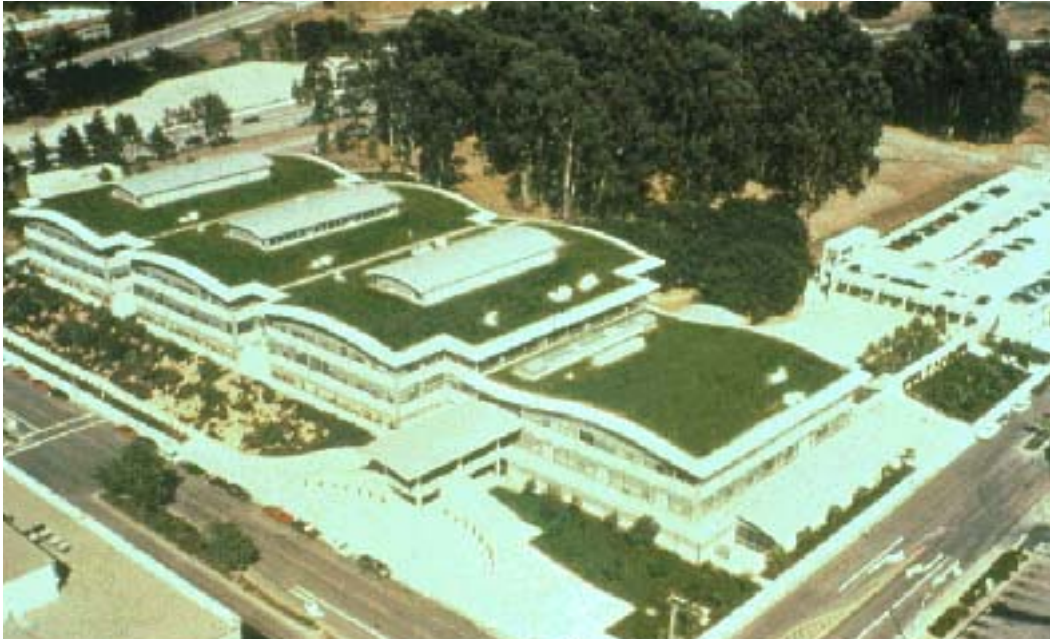
Aerial view of the building's roof garden shows the vegetative areas planted on top of the building made to appear like rolling hills.

- It is estimated that the roof garden captures and stores about 70% of the rainfall. Other benefits include better insulation of the building, reducing the costs of heating and cooling, and mitigating the “heat island effect.”

- The roof was planted using live plugs of six (6) different types of grasses (as opposed to hydroseeding or hand broadcasting) in six (6) inches of soil. The vegetation has grown to form a 5-inch mat of fibrous roots.

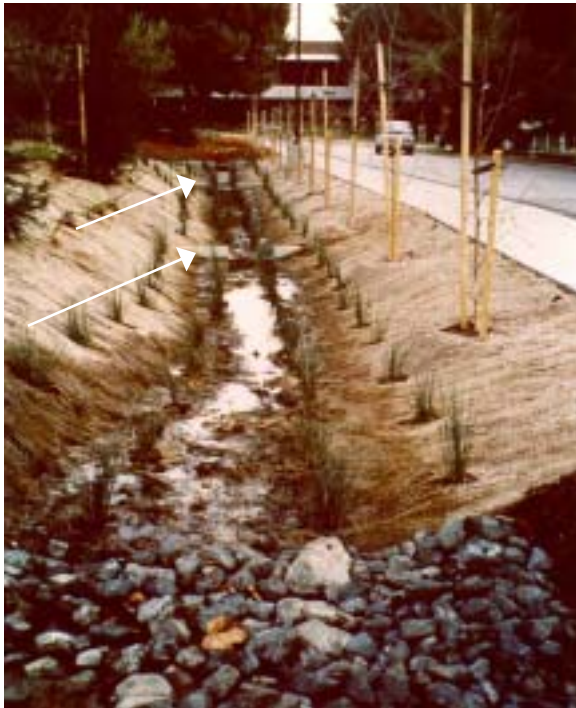
The bioswale, shown before landscaping had fully matured, was planted using native vegetation along the banks. Check dams extend the retention time, allowing for additional infiltration (see arrows).

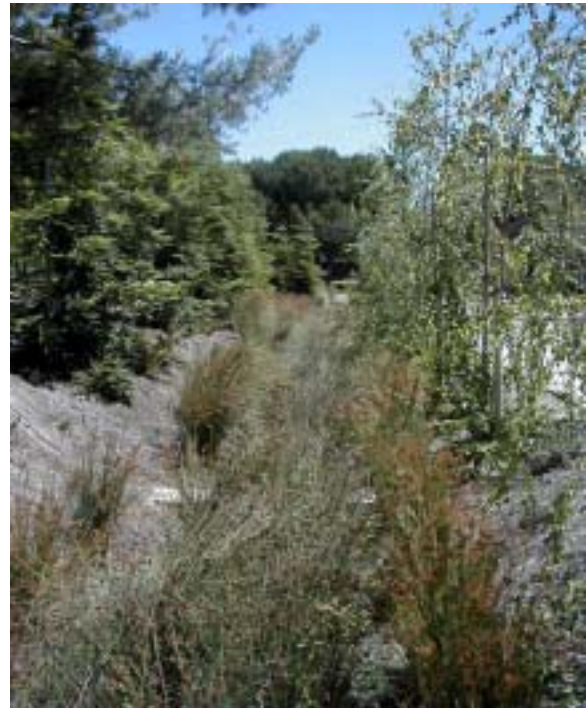
The same bioswale, after landscaping has become established, appears natural and aesthetically pleasing.

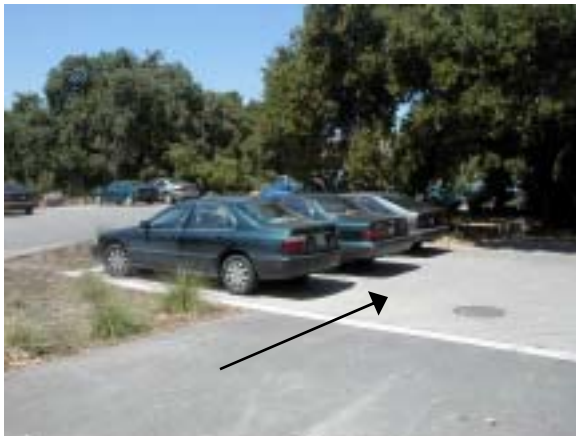
The parking area, adjacent to heritage oak trees, is made of permeable pavement which decreases the amount of impervious surface area at the site.

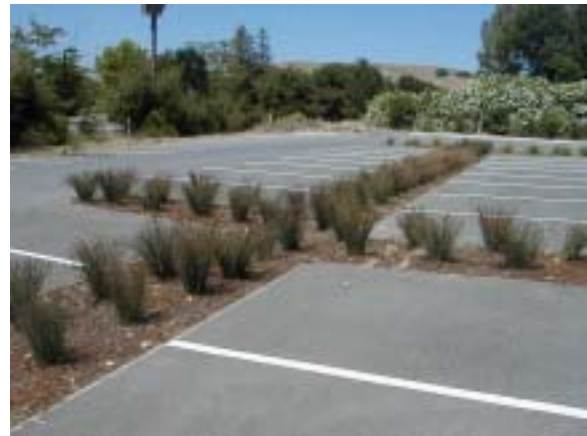
The edges of the vegetated swale are flush with the parking lot, so that runoff can drain into the swale.

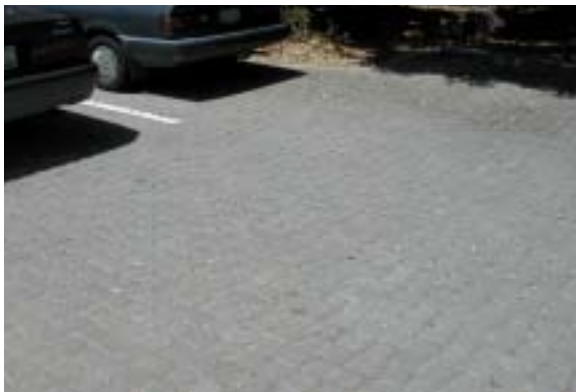
This is a close-up photograph of the permeable pavers in the parking stalls.

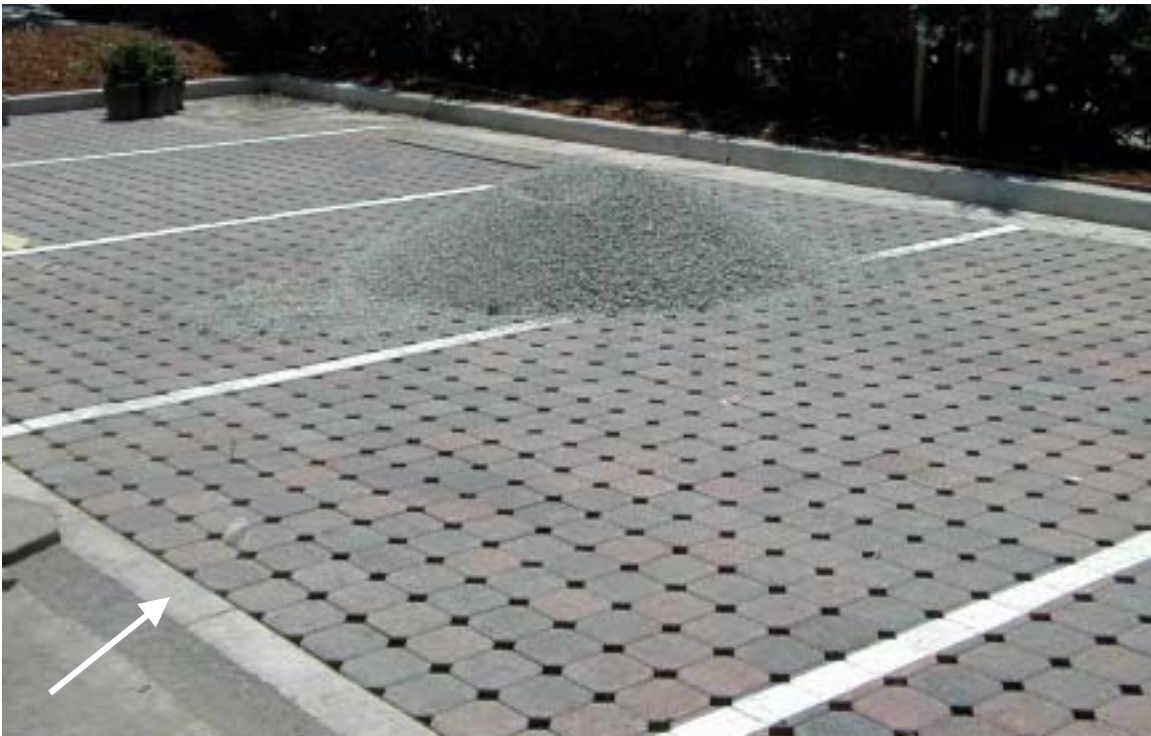
This photo shows the construction of the permeable pavement in the parking area. The spaces between pavers are filled with sand instead of grouted, allowing infiltration through the pavement. The concrete border (see arrow) protects the asphalt from water damage.

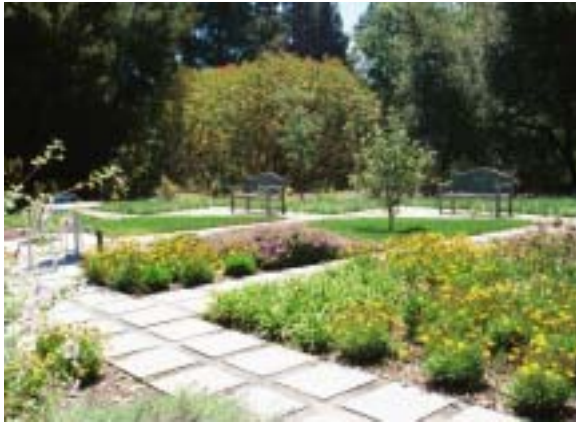
Pervious pathway placed through the courtyard allows easy access for visitors as well as drainage areas for stormwater. The creek runs behind the trees towards the back. Between the trees and the benches is a swale of native vegetation that treats water from the parking lot.

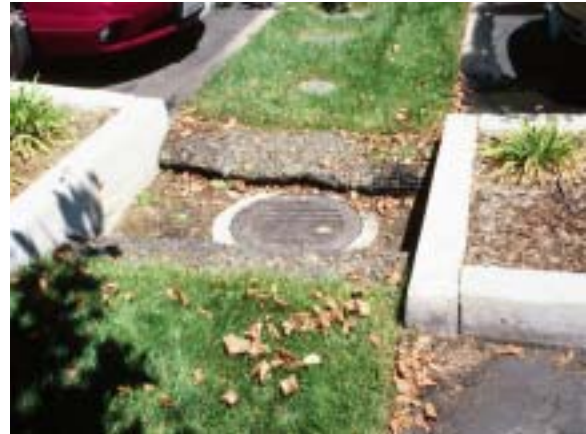
The parking lot design incorporates biofilters to filter and infiltrate runoff before entering the storm drain. Concrete edging protects the asphalt parking lot from water damage.

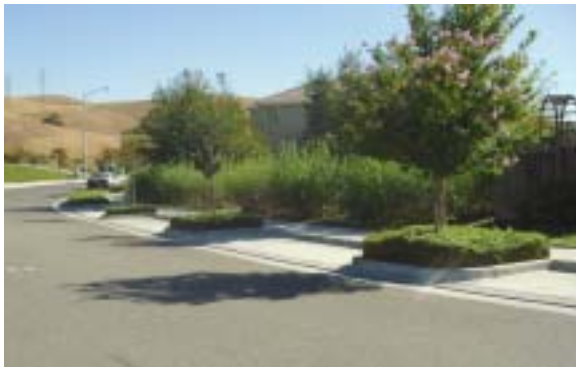
Parking pullouts allow narrower streets that require less land area and provide more space for trees and grass. These landscaped areas reduce the volume and velocity of rainwater and maximize infiltration. Properties on narrow streets with tree-lined landscapes typically have higher property values. The use of narrow streets also reduces construction costs.

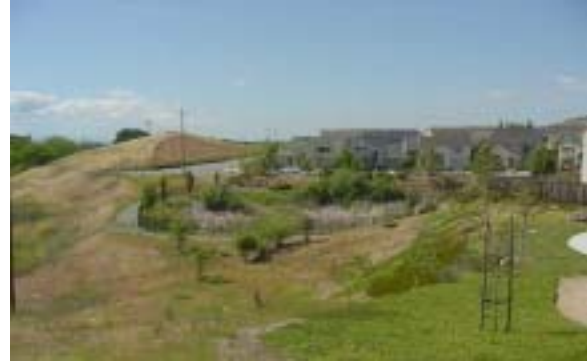
Stormwater runoff is directed into the detention pond which temporarily holds the water, allowing for settling of sediments and pollutant removal to occur. The system releases runoff slowly to reduce downstream peak flows.

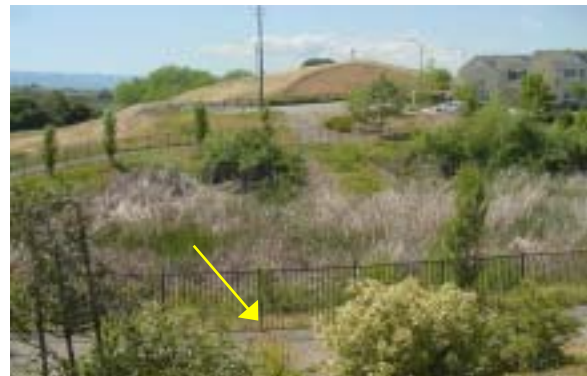
Wetland vegetation helps to remove dissolved metals and nutrients. A walking trail bordering the pond on Dana Court demonstrates how a stormwater treatment device can benefit the environment and be attractive, thereby enhancing the neighborhood character.
