**SGI/Google
CO-4**

**SGI/Google
CO-4 (cont.)**

**Stanford University Medical Center
CO-5**

Gap Corporate Headquarters
CO-6

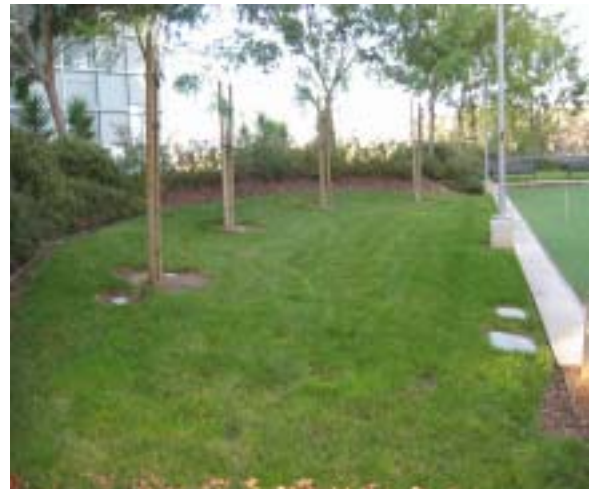
This grassy rooftop area planted with trees reduces and provides some natural treatment of runoff.

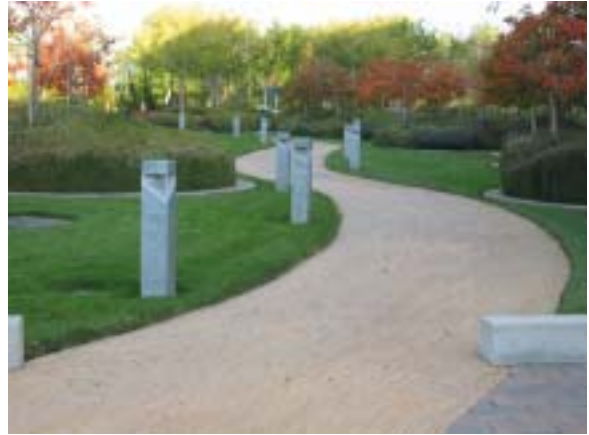
Permeable pavement and landscaped areas fill the courtyard on top of the parking structure.

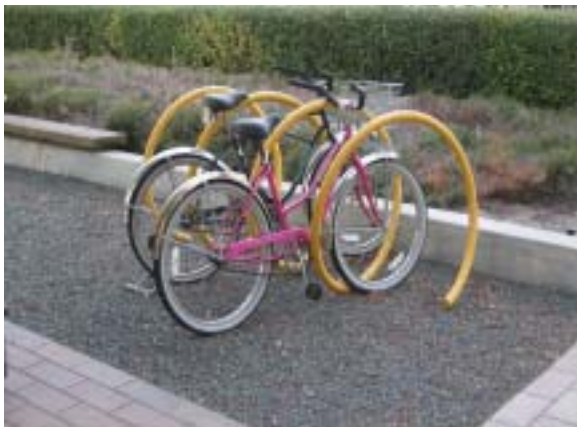
Bike racks promote alternative transportation, perhaps providing easy access to other buildings on the campus.

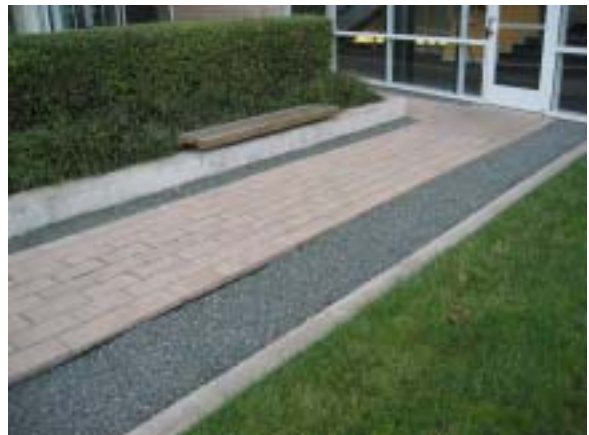
Turf and gravel surrounds this pathway, providing an area for infiltration to occur.

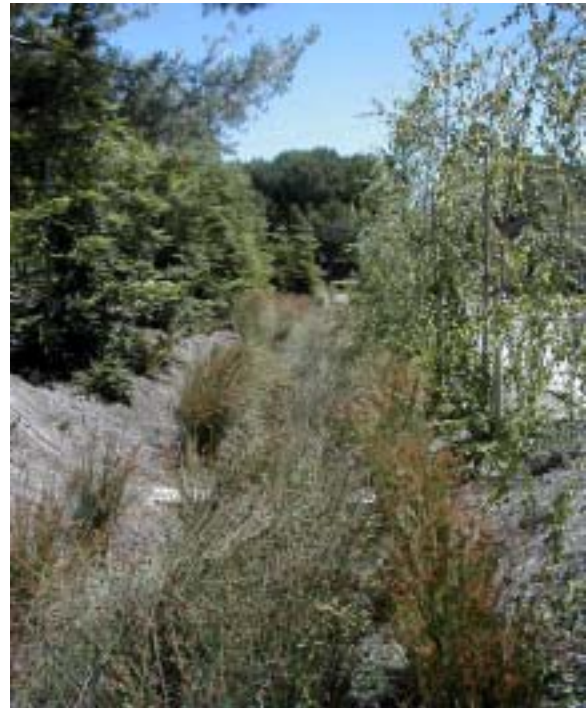
The same bioswale, after landscaping has become established, appears natural and aesthetically pleasing.

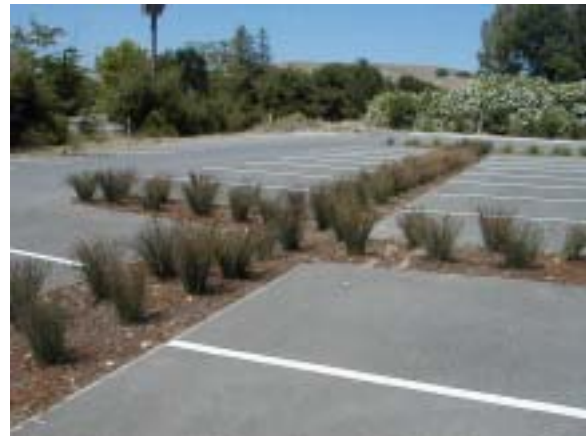
The edges of the vegetated swale are flush with the parking lot, so that runoff can drain into the swale.

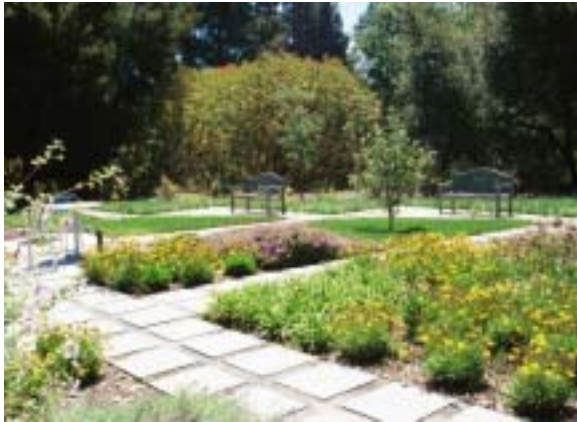
Pervious pathway placed through the courtyard allows easy access for visitors as well as drainage areas for stormwater. The creek runs behind the trees towards the back. Between the trees and the benches is a swale of native vegetation that treats water from the parking lot.

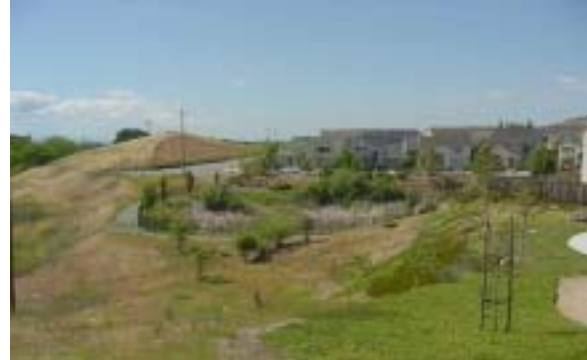
Stormwater runoff is directed into the detention pond which temporarily holds the water, allowing for settling of sediments and pollutant removal to occur. The system releases runoff slowly to reduce downstream peak flows.

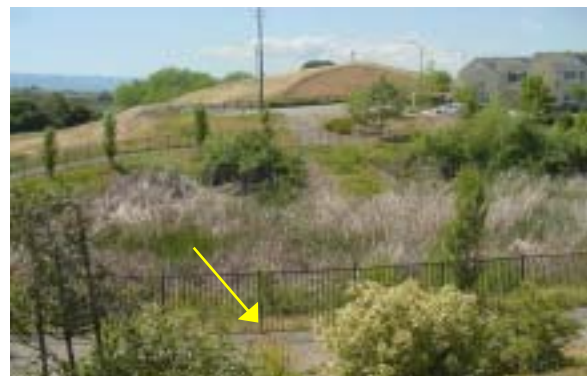
Wetland vegetation helps to remove dissolved metals and nutrients. A walking trail bordering the pond on Dana Court demonstrates how a stormwater treatment device can benefit the environment and be attractive, thereby enhancing the neighborhood character.
