**Agilent – Palo Alto
CO-1**

**Yahoo! Inc.
CO-7**

**Juniper Networks
CO-8**

Blossom River Apartments MF-5

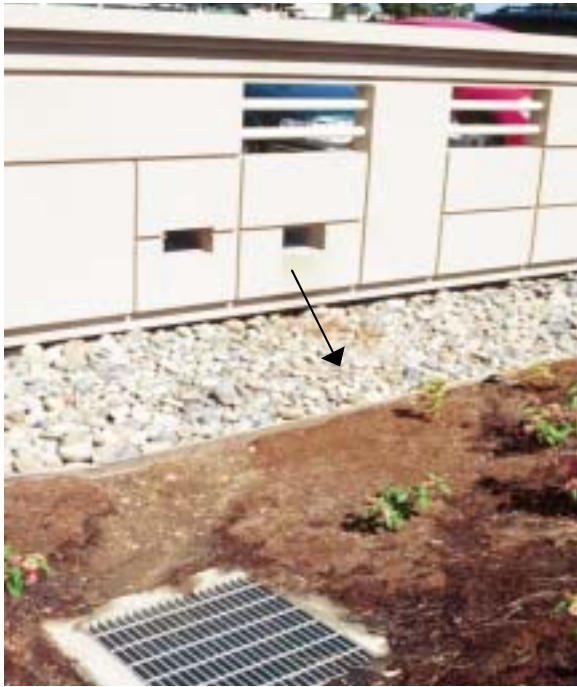
The runoff drains from the top of the parking structure to this rock filter bed for treatment and then to the storm drain system via the detention basin.

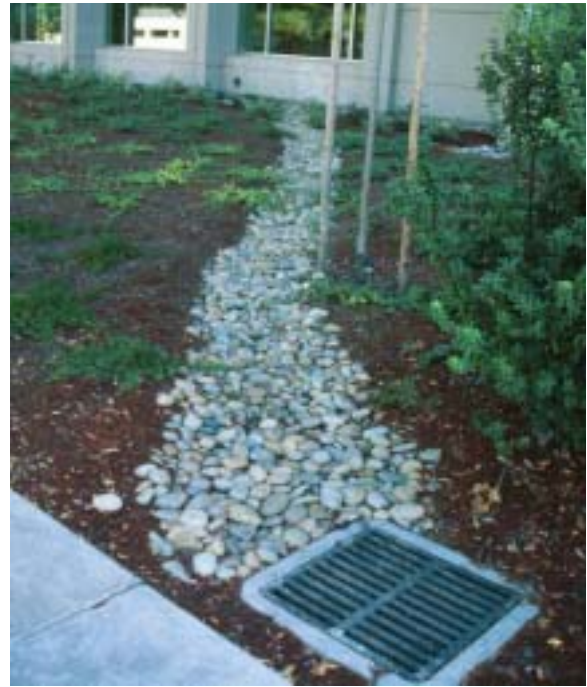
This rocky swale is used to slow and treat rooftop runoff before draining to the storm drain. A minimum two percent (2%) slope away from the building protects the building foundation from water damage.

- The site designer highly recommends checking after the first rain to make sure the entire system is working correctly. For the roof downspouts, the rainwater initially started pooling behind the header boards at the bottom of the roof downspouts. Notches cut in the header board ensure proper drainage away from building with a minimum 2% slope.

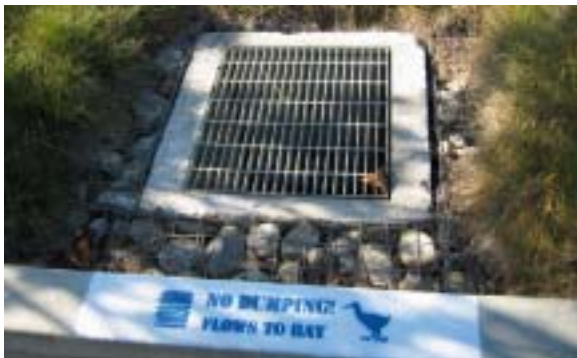
Storm drains are clearly labeled with an educational “no dumping” message.

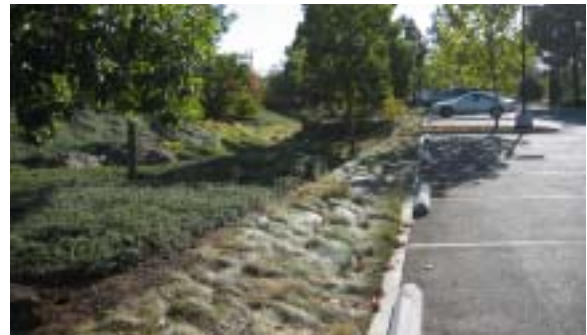
The detention basin collects water from the parking lot. The concrete edging protects the asphalt from water damage while the bumper stops help prevent cars from traveling over the vegetated swales.
