**Agilent – Palo Alto
CO-1**

**Yahoo! Inc.
CO-7**

**Juniper Networks
CO-8**

**Baylands Parking Lot
PA-7**

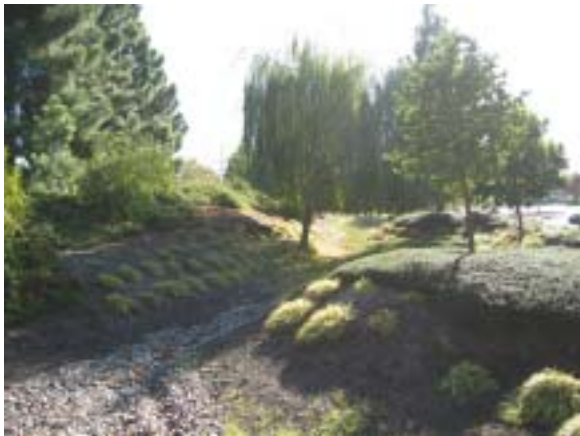
The detention basin, known as “The Swale” by Agilent employees, provides stormwater collection and treatment for the parking areas, visual amenities for employees, and a visual buffer for the neighboring residential community.

- The detention basin has also served as a useful indicator for irrigation leaks for sprinklers within the parking lot biofilter landscaping. When maintenance staff sees ponded water in the detention basin during a dry spell, they investigate for potential leaks.

- Shredded bark was installed initially along the detention basin banks to hold the soils without clogging the system until vegetation became established.

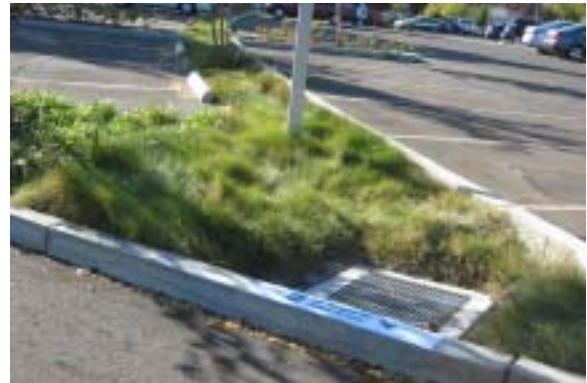
The parking lot is graded to drain into vegetated swales, shown here, and the detention basin.

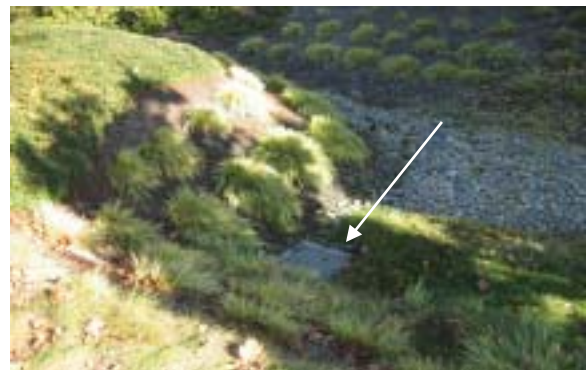
Storm drains from the parking lot enter the detention basin through drains like this one.

- During the rainy cloudy days, the water in the parking lot catch basins may take longer than 72 hours to drain. Maintenance staff must periodically clean debris from catch basins.

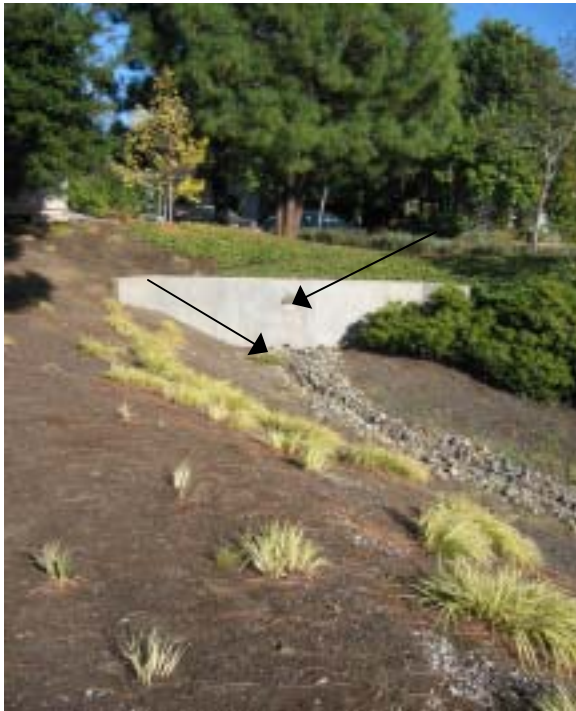
The detention basin has two outlets to protect against localized flooding and to ensure that the basin drains within 72 hours for vector control.

- The irrigation heads originally installed for the retention basin caused some ponding for greater than 72 hours until they were modified to target areas requiring water. The local vector control agency brought mosquito fish for mosquito control while the irrigation challenge was being diagnosed and addressed.

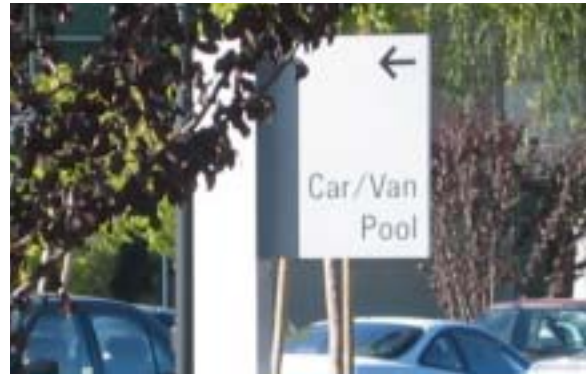
Agilent encourages employees to carpool by providing designated car/van pool areas. Reducing vehicle trips traveled reduces the amount of pollutants such as hydrocarbons and brake pad dust released to the environment.

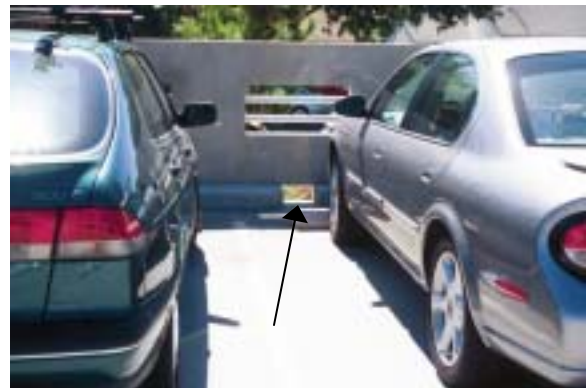
Runoff from this parking structure drains to the filter bed, described below. The two-story parking structure allows for roughly twice the number of vehicles for the same area of a typical surface parking lot, while allowing enough room on-site for the detention basin.

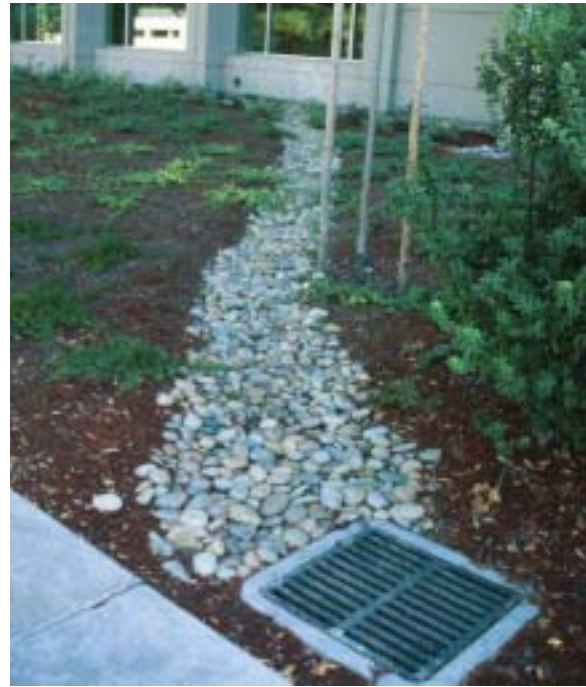
This rocky swale is used to slow and treat rooftop runoff before draining to the storm drain. A minimum two percent (2%) slope away from the building protects the building foundation from water damage.

- The site designer highly recommends checking after the first rain to make sure the entire system is working correctly. For the roof downspouts, the rainwater initially started pooling behind the header boards at the bottom of the roof downspouts. Notches cut in the header board ensure proper drainage away from building with a minimum 2% slope.

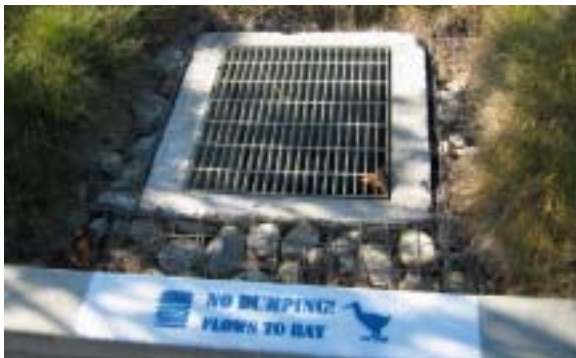
Storm drains are clearly labeled with an educational “no dumping” message.

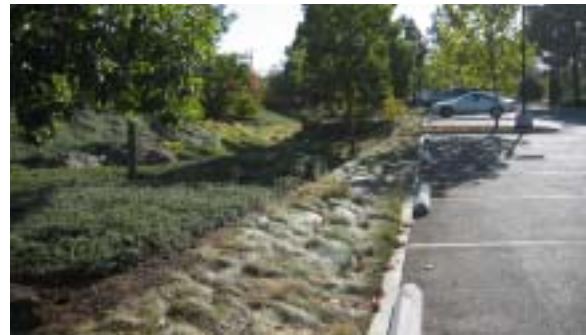
The detention basin collects water from the parking lot. The concrete edging protects the asphalt from water damage while the bumper stops help prevent cars from traveling over the vegetated swales.

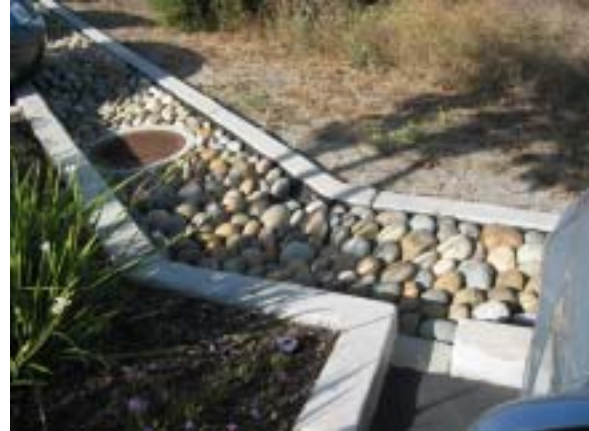
This rocky swale has a storm drain for excess flows.

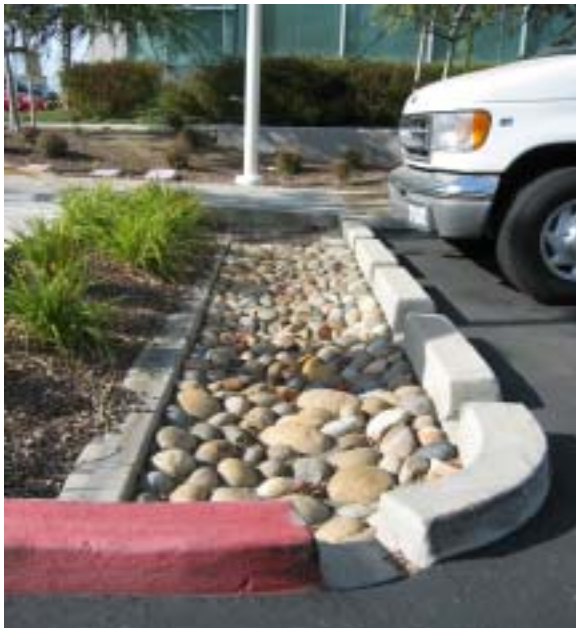
Rocky swale with curb cuts allows for infiltration to occur.

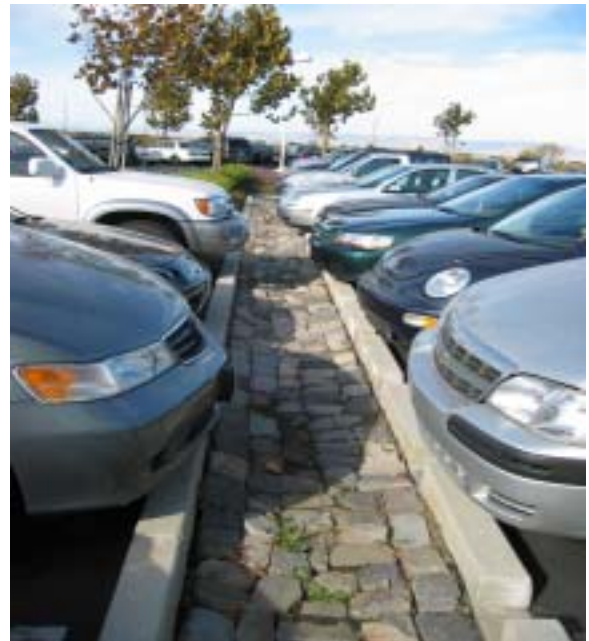
Rectangular stones are used to create a rocky swale.

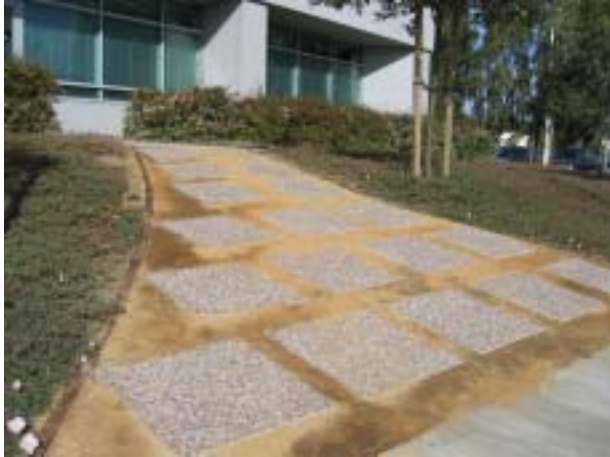
Pervious walkways used to minimize impervious surfaces.

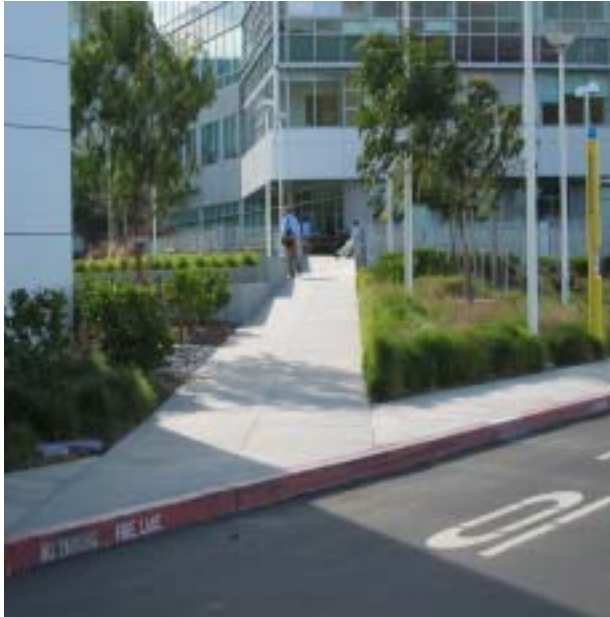
This walkway slopes toward landscaped vegetation; with multi-story buildings in background.

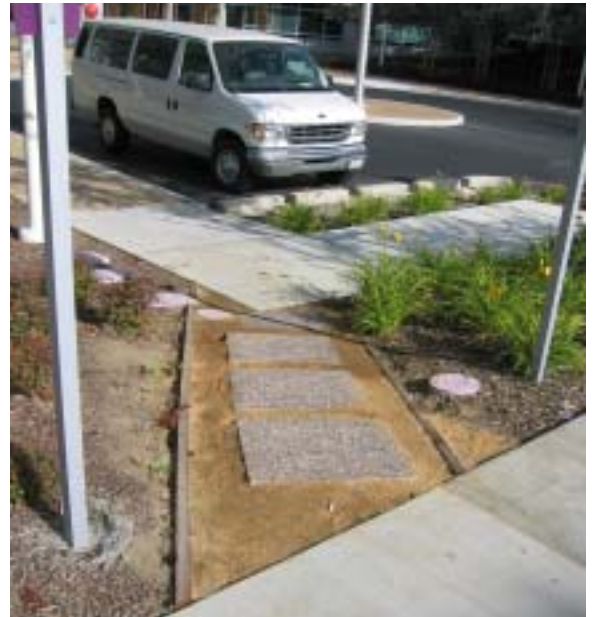
Pervious walkways used between concrete sidewalks.

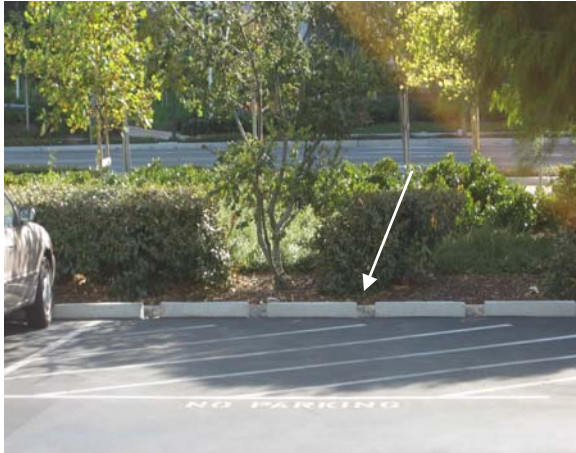
Curb cuts (see arrow) allow runoff to drain off parking lot into the vegetation.

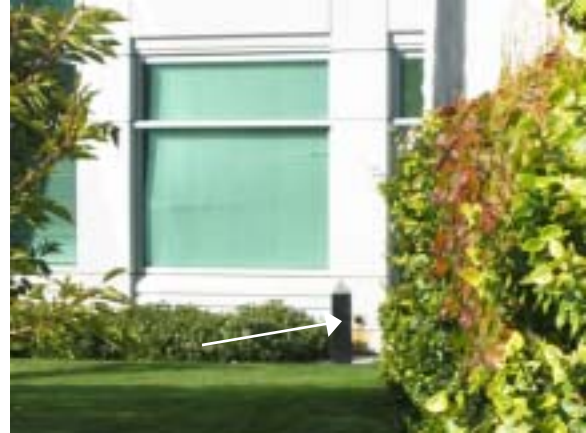
Runoff from rooftop drains into landscaping reducing the directly-connected impervious area (DCIA).

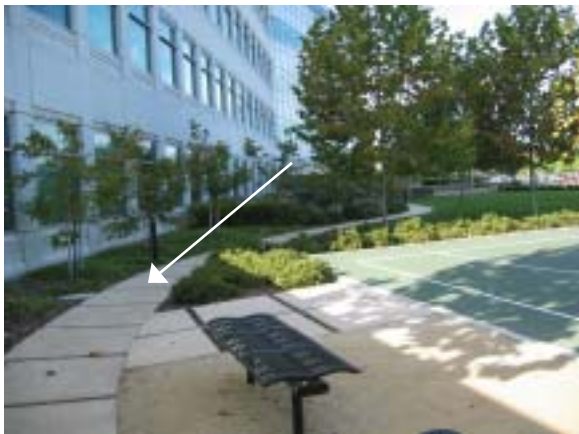
This pathway made of pervious pavers allows infiltration through the sand filled crevices. Also, these benches are provided on pervious surfaces.

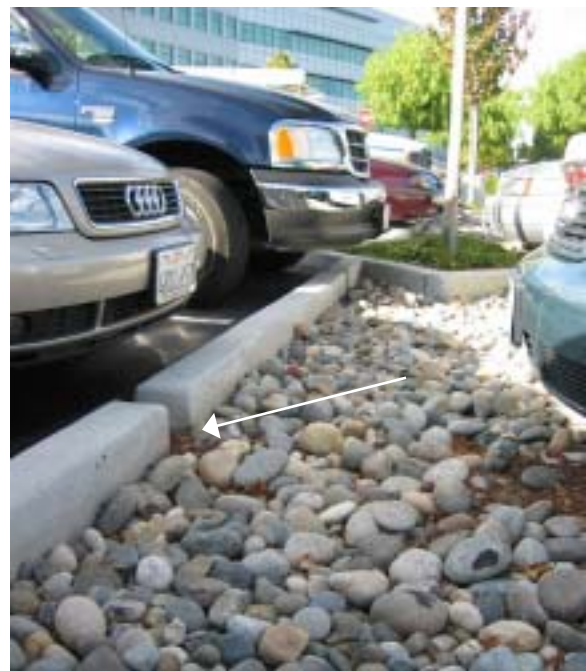
Parking lot runoff drains through curb cuts and then filters through the rocky swale. Trees provide visual amenities as well as reduce the volume and velocity of runoff.

- During storms, ponding does occur in parking lots. This can be prevented through better design and construction of the rocky swales to ensure that the infiltration rate of the swale is fast enough to prevent ponding, or by adding a perforated drainage pipe for runoff overflow. It is also important that the site is graded properly to direct water toward the swale.

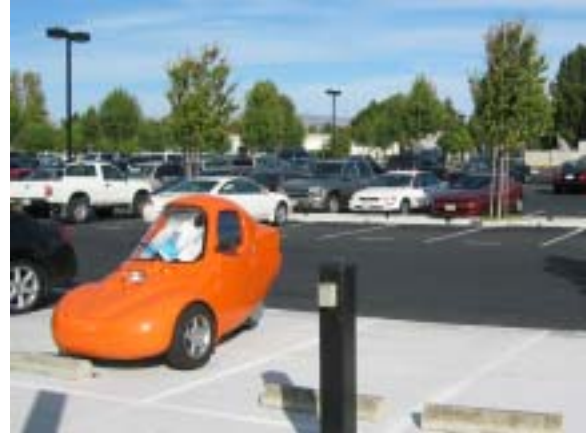
Charging stations allow employees with electric vehicles, like the Sparrow pictured here, to charge-up while at work.

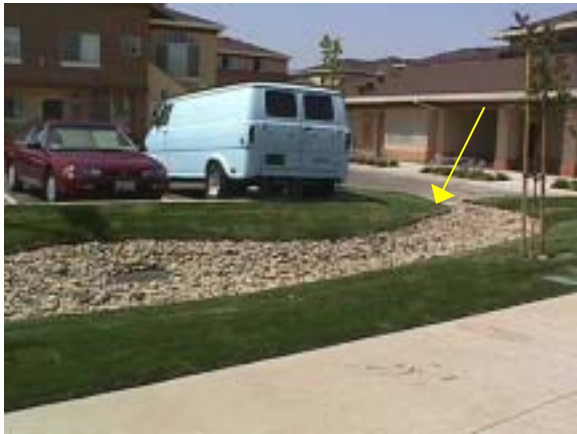
Photograph courtesy of Mike Campbell (RBF Consulting)

Runoff enters the rocky swale from the parking lot and is filtered before entering the storm drain.

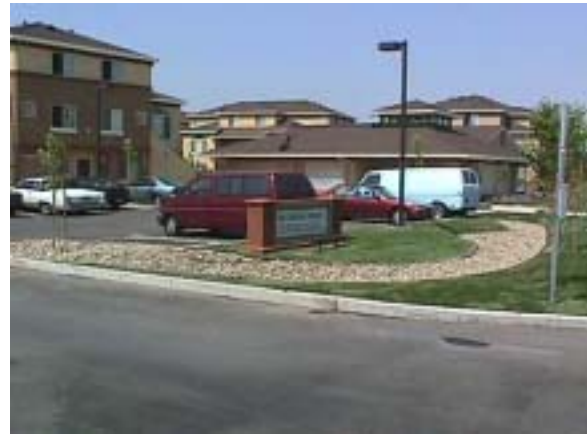
Photograph courtesy of Mike Campbell (RBF Consulting)

Turf landscaping around the rocky swale provides an area for infiltration. Multi-story buildings reduce the building footprint.

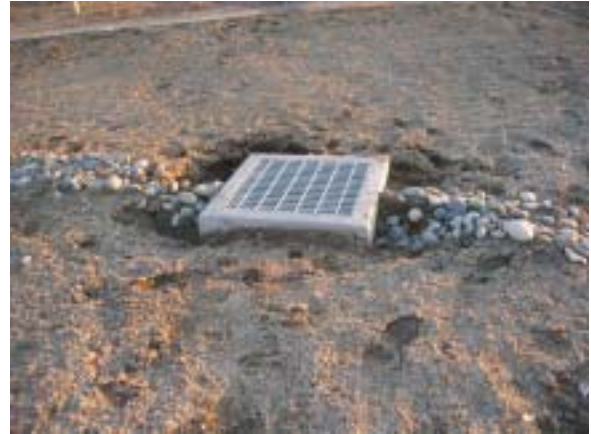
The filtered runoff drains into this storm drain at the downstream end of the swale.

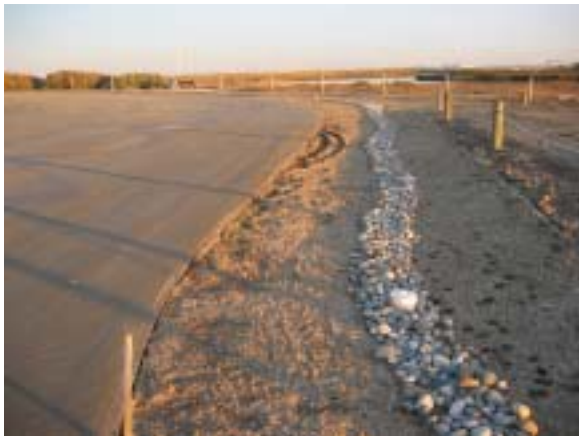
The bioswale surrounds the parking lot, providing runoff treatment before it drains to the storm drain.

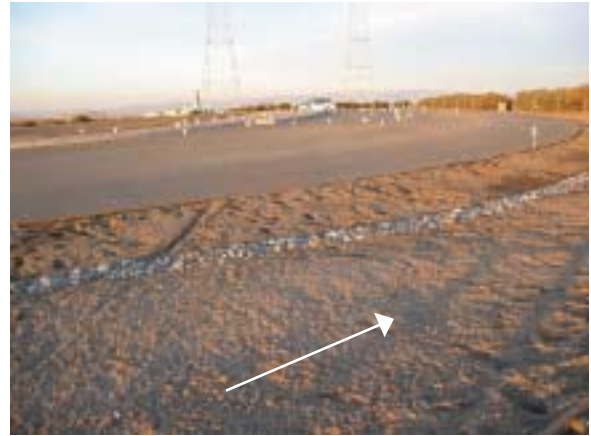
Parking lot is graded so that runoff drains into the swale.
