**Agilent – Santa Clara  
CO-3**

**SGI/Google  
CO-4**

Stanford University Medical Center  
CO-5

Gap Corporate Headquarters  
CO-6

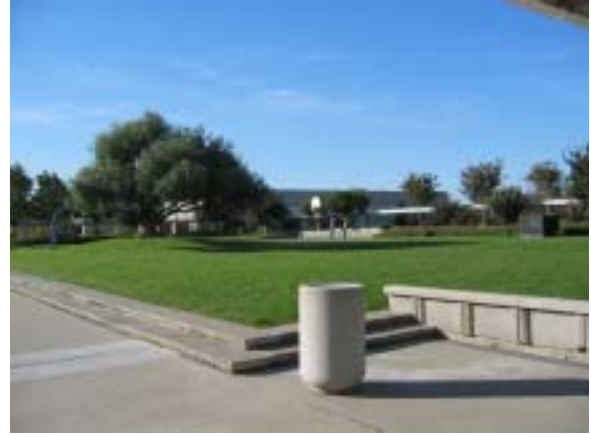
Large areas of vegetation are located on top of the second floor of the office building.

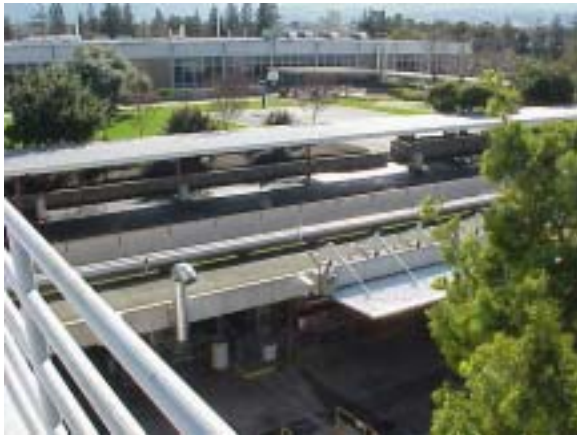
The roof garden is located on the second floor of the Agilent building.

- Leakage occurred due to roots penetrating the roof membranes, however after patching the barriers underneath the garden, leakage was prevented.
- The membrane integrity was also compromised by heavy vehicle traffic (for deliveries to the café on the roof garden level). The amount of deliveries was minimized to prevent more leaks.

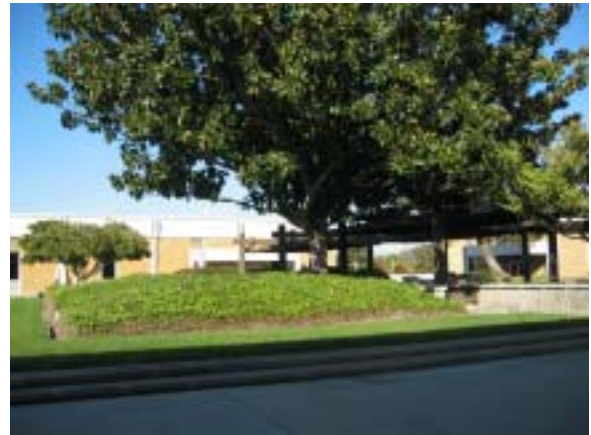
Trees are planted as part of the roof gardens.

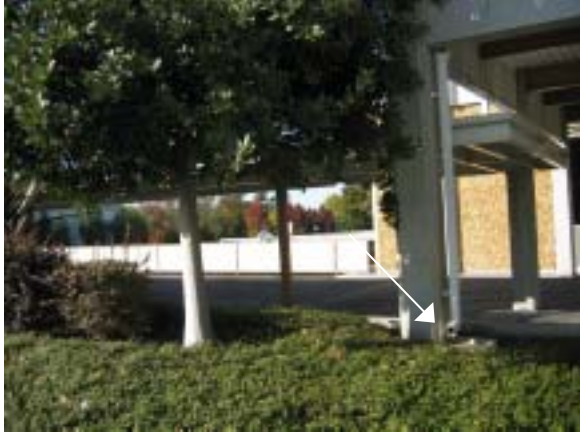
Rooftop runoff is directed to drain through the vegetation.

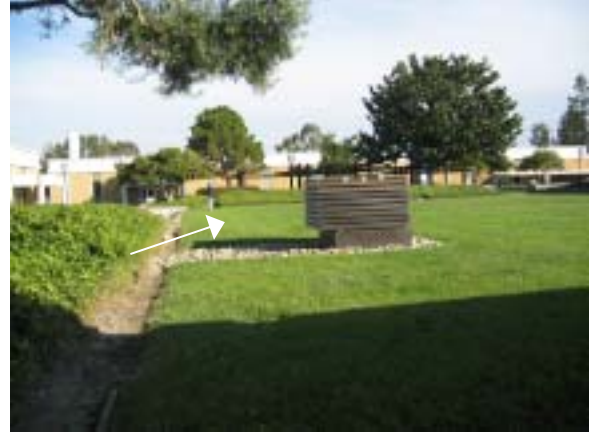
Exhaust vents for HVAC\* systems are integrated into roof garden areas.

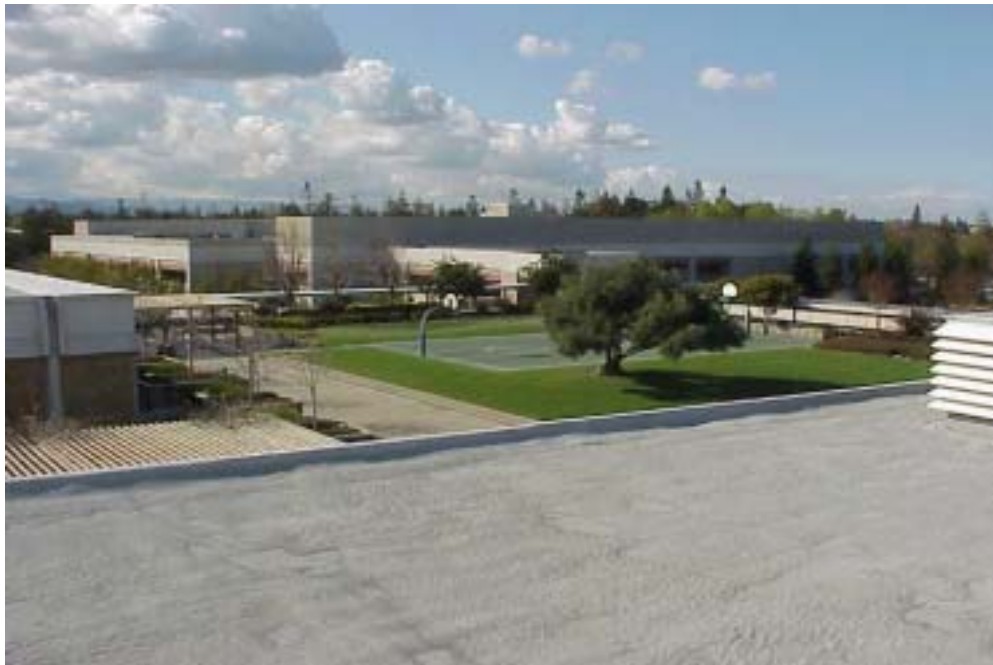
Another view of the roof garden shows a large shady tree that can reduce rainfall velocity and runoff.

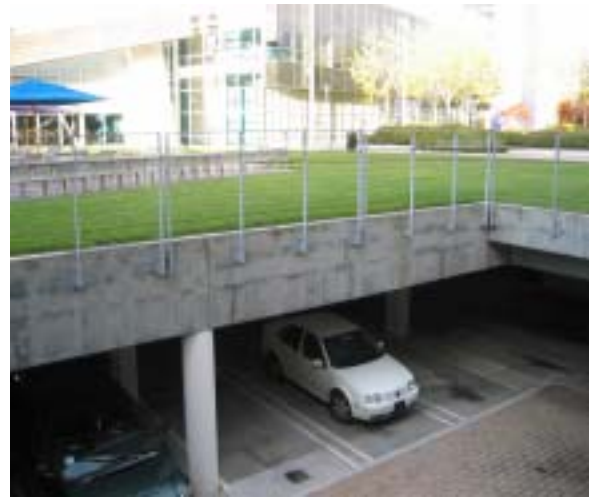
The parking lot can be seen below the turf on the level above.

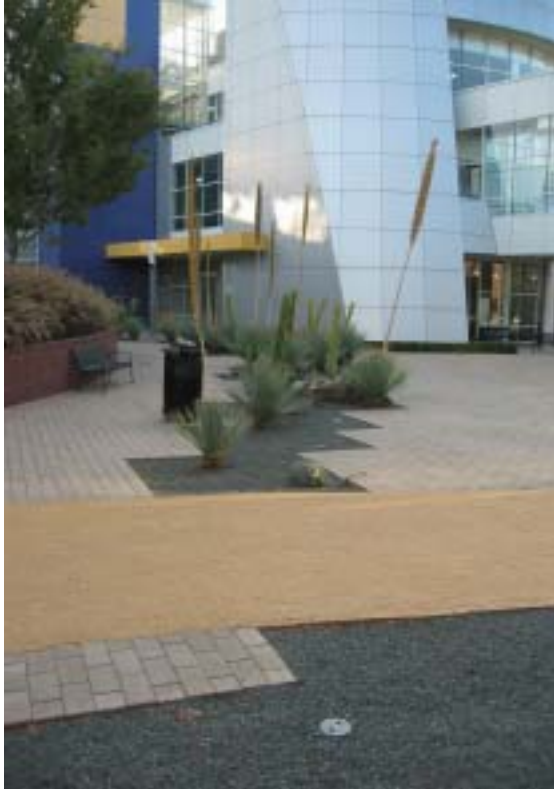
Permeable pavement and native vegetation surround this multi-story complex.

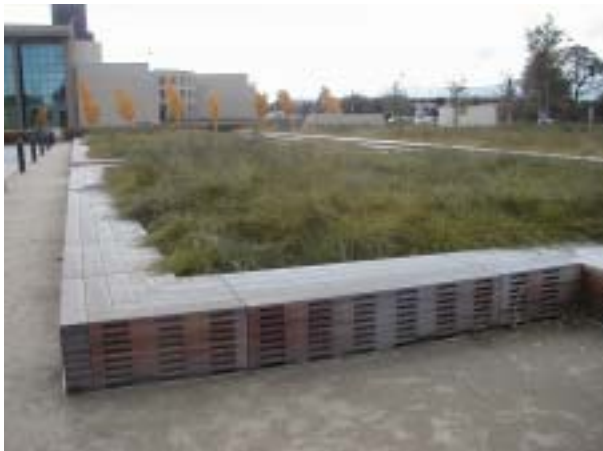
This roof garden provides not only aesthetic benefits, but also a large area for stormwater infiltration to occur.

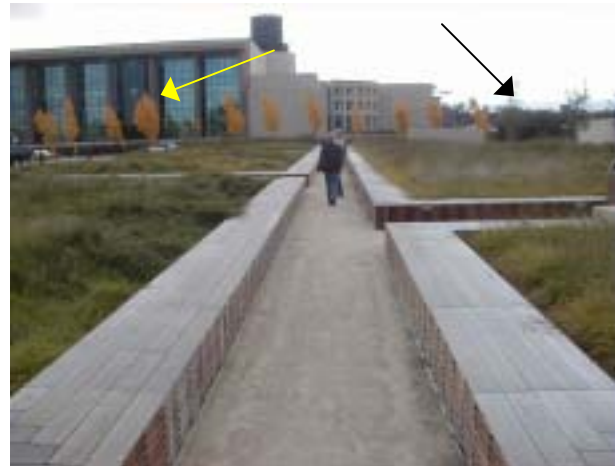
At the end of the pathway, trees line the nearby street. The trees and the rooftop vegetation reduce the volume and velocity of stormwater runoff while providing for some natural treatment.

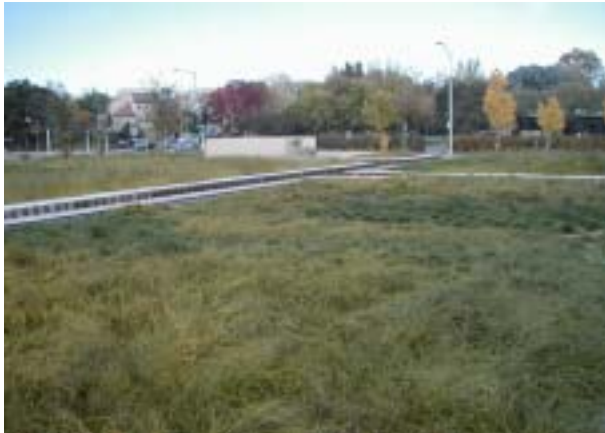
The roof garden uses only one type of vegetation, which facilitates maintenance.

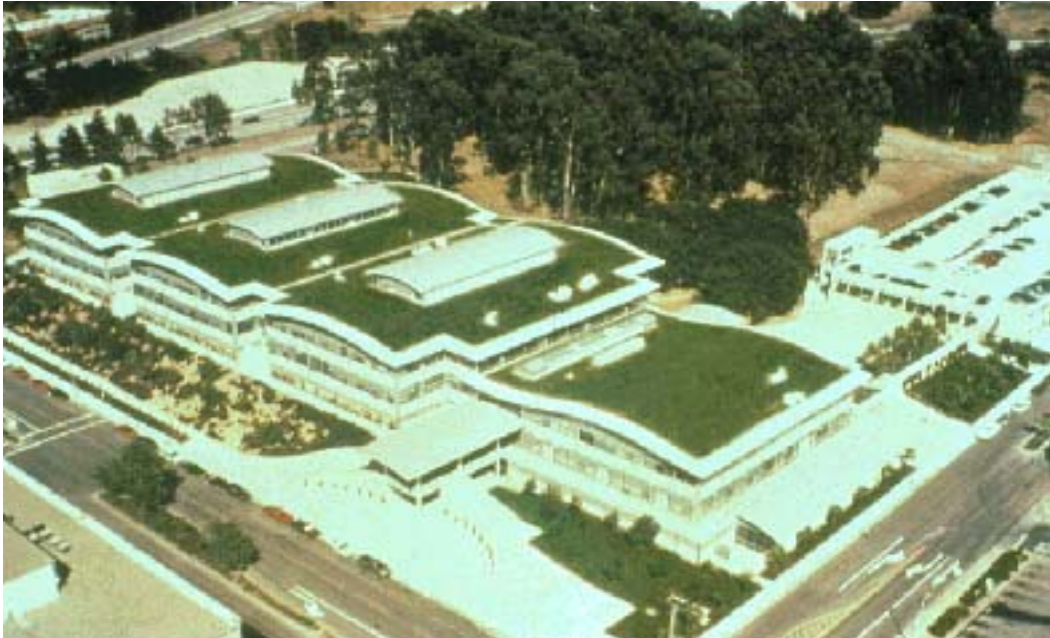
Aerial view of the building's roof garden shows the vegetative areas planted on top of the building made to appear like rolling hills.

- It is estimated that the roof garden captures and stores about 70% of the rainfall. Other benefits include better insulation of the building, reducing the costs of heating and cooling, and mitigating the “heat island effect.”

- The roof was planted using live plugs of six (6) different types of grasses (as opposed to hydroseeding or hand broadcasting) in six (6) inches of soil. The vegetation has grown to form a 5-inch mat of fibrous roots.
